HISTORIC STRUCTURES REPORT AND CONDITION ASSESSMENT

GREEN-MELDRIM HOUSE

1 West Macon Street
Savannah, GA, 31401

20 April 2007

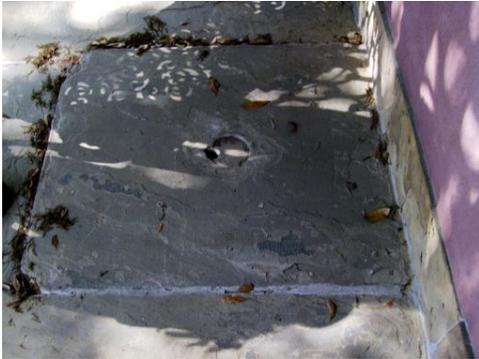
2. **East Veranda:** There is a floor access flagstone set behind each chimney (See Figure 21). The northernmost has a small hole in the middle, and is mortared shut. The

Figure 3: Chimney base access

southernmost flagstone has no lifting hole, but can be levered open. Inside is a brick lined chamber 7'6" deep and 6'0" x 2'6" in plan at the top. The east (outward facing) wall goes straight down the 2'6" height of the veranda above ground. It then expands into a shallow horizontal arched retaining wall. The (west) chamber wall/main front wall foundation steps out one brick below floor level. The brick is the same English brick of which the rest of the house is constructed.

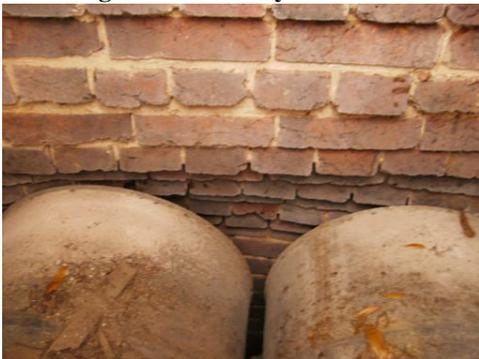
Figure 4: South east chamber

A possible flue cleaning access point, or heating duct originates near the top of the chamber under the chimney stack. Inspection of the top of this stack shows there are two flues, one for each of the fireplaces in the two rooms above. Two 55 gallon oil drums are wedged into the chamber midpoint, blocking the view below. They could be either a safety precaution due to the depth of the chamber, or may be part of a 20th Century oil heating system.

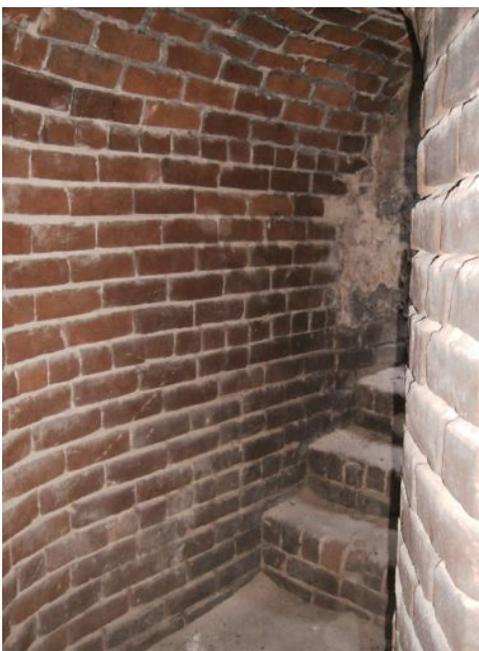
Figure 5: Furnace room

There is an almost horizontal galvanized pipe in the southeast corner leading towards the southwestern chimney stack. This may be a modern pipe placed inside an older brick vent that leads to the same chamber arrangement as described above. There is no staining from flue gas so it may be a heating duct. Remains of a smaller east opening may be a flue to an odd single flue chimney stack seen on the roof between the two large west stacks.

This, combined with the room's small size (approx 2'6" x 5'8"), indicates an oil or gas furnace. A large HVAC duct from the return air grill in the floor of the adjacent cross hall fills much of the chamber, bending 90 degrees from east to north. On the west wall an opening approximately 12" x 18" leads outside. It is now filled with rubble including bits of the original Parish House tile floor removed in 1968. This opening is directly under one of the load bearing cast iron columns of the back piazza, undermining it. Difference in the brick and the undermining of the column suggest the chamber was added after the house was built.

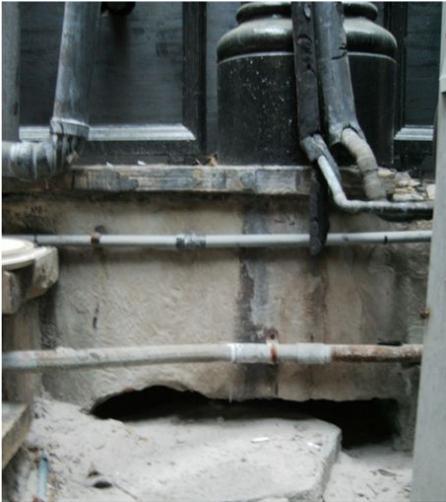
Figure 6: Furnace room opening under piazza column.

- As a result of the removal of the foundation to the back piazza column, there is a small settlement crack in the stucco covering to the beam above this column, two stories up.
- The Harris Street grate cannot be locked and represents a security risk.

- **Parish House Column Foundation (Priority 1):** Determine if there is a beam holding up the column over the furnace room vent. If not, fill furnace room opening and install a new support system. (Do archaeological analysis of rubble; identify and keep important pieces).

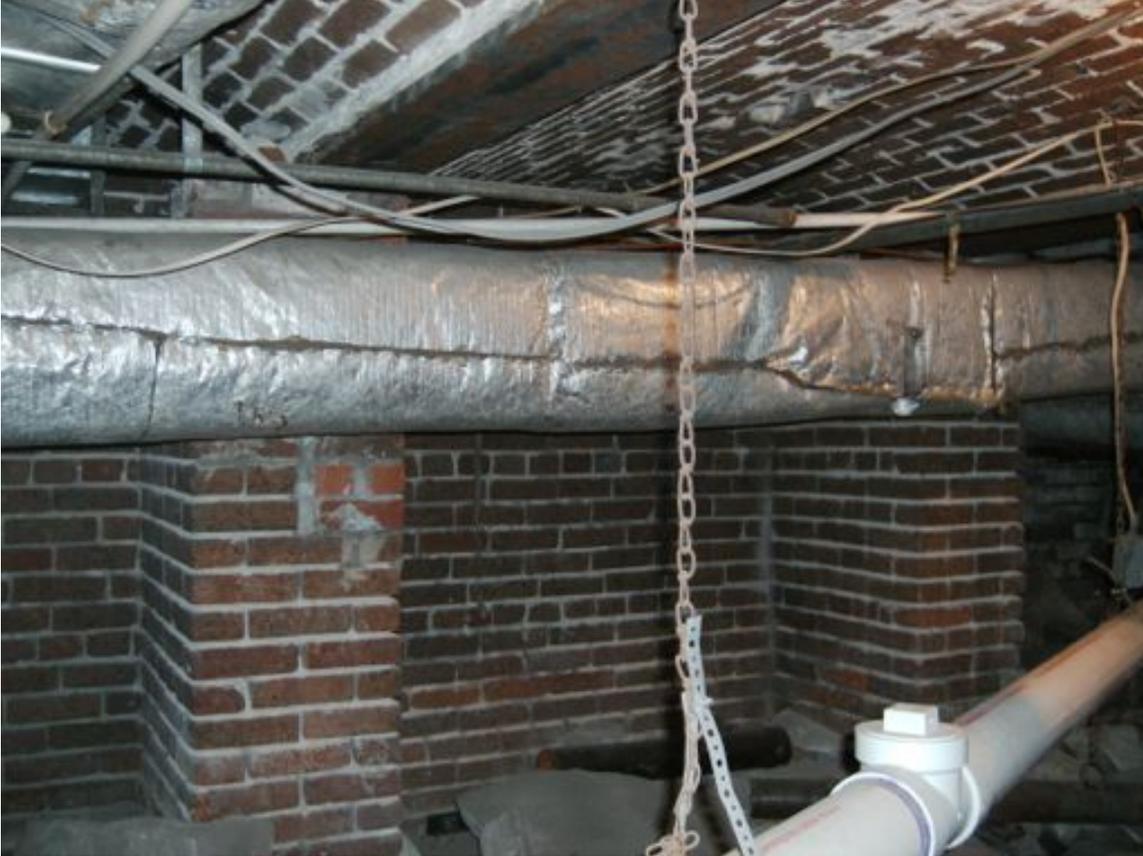
Figure 7: Rectory cellar

- There is no sign of dampness rising from the foundations of the Parish House.
- The exterior (Harris Street) wall of the Rectory cellar is supersaturated, with disintegrating mortar and wet bricks.
- The bottom of the Harris Street cellar entrance shaft is swampy and a sump pump has been installed draining into the old well/drain.

- **(Priority 1):** Confirm the source of the cellar flooding.
- **(Priority 1):** Test all the underground drains for leaks and blockages.
- **(Priority 1)** Confirm the source of the water at the base of the Harris Street access shaft and coming through the north cellar wall. This may be a broken city pipe. The water meter box and associated city water access points are only a few feet away in the tree lawn, and a sprinkler supply pipe leads through the cellar to the Rectory garden.

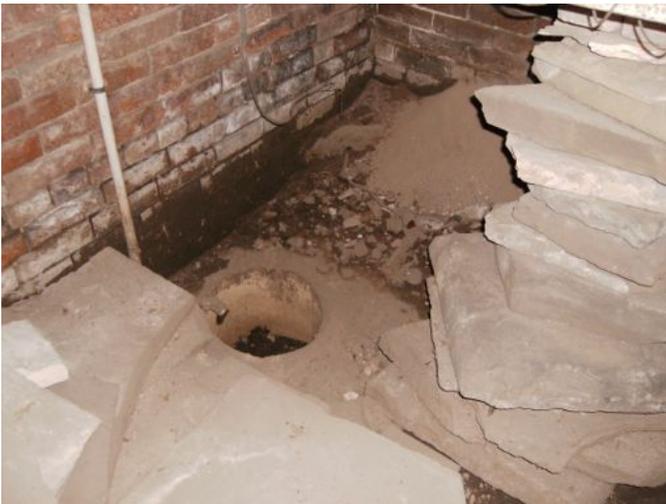
- The flagstone sidewalk adjacent to the cellar entrance shaft is settling and shows signs of washout or another underground chamber.
- The cellar appears to have been flooded on a regular basis, partially from the Whitaker Street sidewalk grating described above. This is a result of poor street drainage (grating is barely above gutter level).
- The cellar well or drain may also be a source of flooding, possibly being connected to a blocked storm sewer.

Figure 8: Cellar well or drain

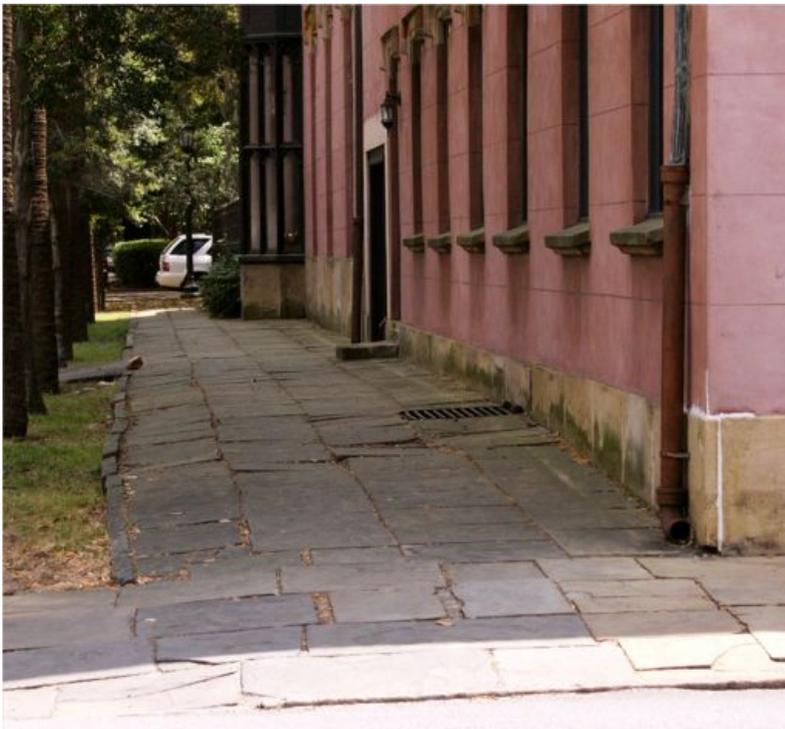
Figure 9: Cellar grate in Harris Street sidewalk

- **(Priority 1):** Determine alternative source for Rectory under-floor venting than the Whitaker Street grating, which should be filled.
- **(Priority 2):** Whitaker Street wall foundation should be exposed at the base of the crack to investigate the condition of the foundation and possible damp source.
- **(Priority 2)** Take up flagstones in maintenance room to investigate base of the Rectory east interior cross wall

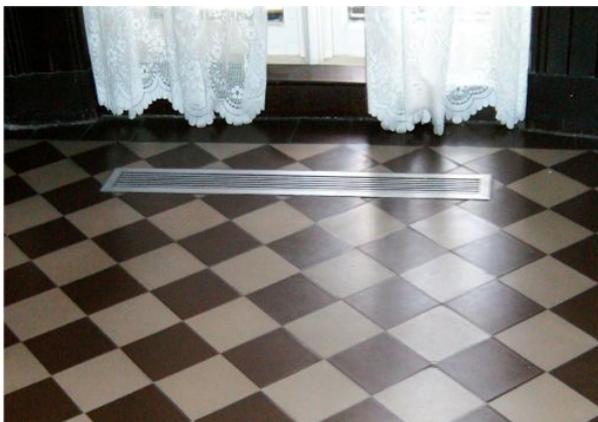
- The Parish House under-floor spaces do not appear to be vented, but there is no sign of dampness or mold.
- In 1968, in order to install the under-floor HVAC system, the original floor tiles

Figure 10: HVAC grill in Dining Room floor

- (but not the original slate) were removed for access. Similar new tiles were laid throughout in their place. They made no provision at the time for future maintenance access.
- All wooden floors are in excellent condition.
- There is no way to access the east end of the Rectory attic as the way is blocked by a chimney and HVAC ductwork.

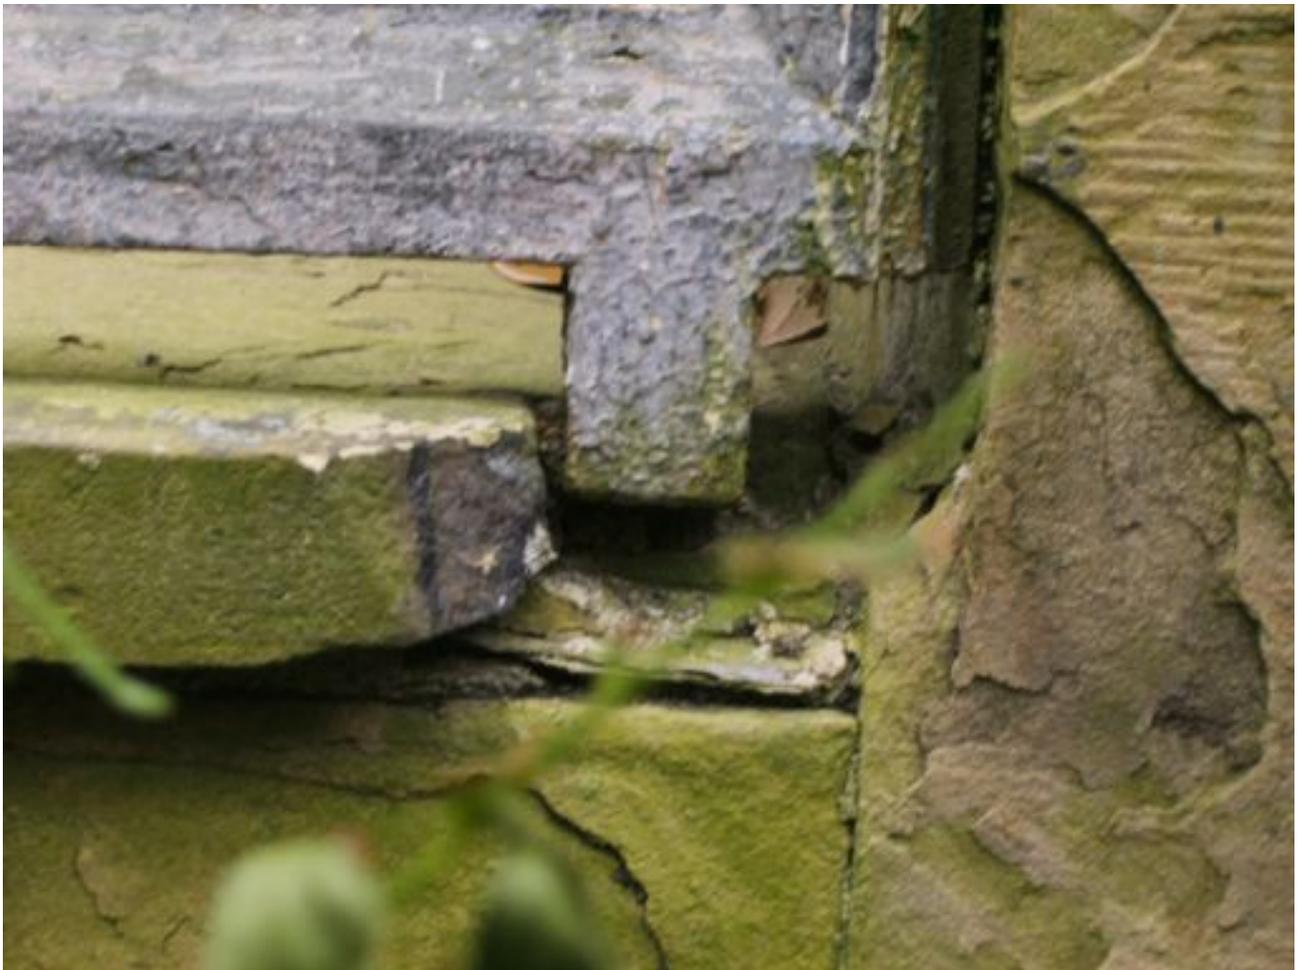
trellis supports. Expansion of the iron has caused cracking and spalling at the support points, leaving parts of the veranda roof and decorative ironwork unsupported.

Figure 13: Eroded support to veranda trellis

- Trellis sits directly on soft sandstone which has eroded, leaving the trellis work inadequately supported, particularly on the north east corner (see Figure 13).

- **Veranda Floor (Priority 1):** In the areas where the sandstone flagstones have worn away around the iron trellis supports, use properly tinted Jahn M70 mortar or equivalent to repair the missing stone. Prior to repair, prep the iron railing to remove all rust and recoat to prevent future oxidation.
- **Veranda and Back Piazza Floor (Priority 1):** In areas where delamination has caused ponding water or a tripping hazard, resurface the remaining sandstone to a smoother finish by means of pneumatic tools or refinishing equipment. Otherwise leave as is.

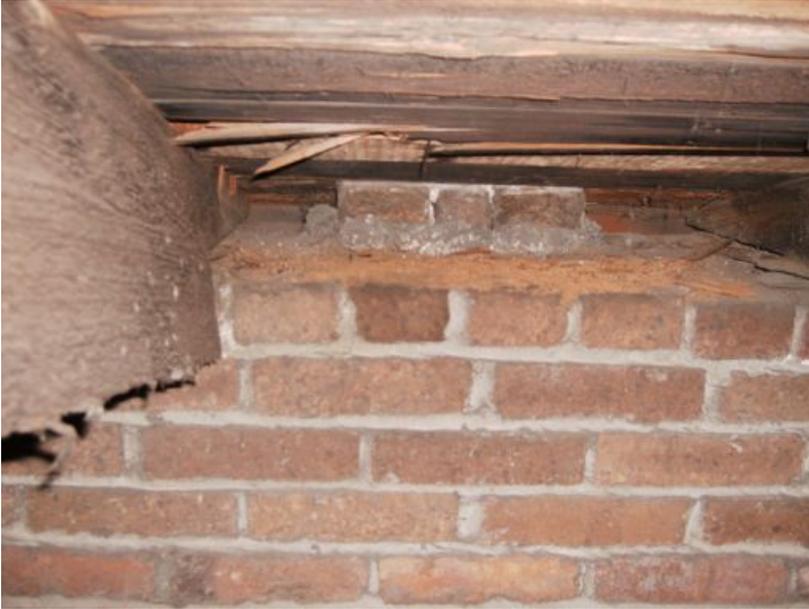
Figure 14: Parish House North and South rafters, with brick parapet support

- Main Roof and Rectory Roof: The joists do not appear to be attached to the brick wall with any great security, rather simply resting on them. However, the weight of the heart of pine roof, the lack of exposed edges (other than the back piazza), the parapet anchoring system, and the large chimney stacks penetrating the roof provide enough security for the house to have withstood the great hurricane of 1893 (the last severe hurricane to hit Savannah).
- The perimeter roof decking is damaged by an excessive number and size of nails used for roof repairs in 1950's, including tie-backs to parapet stones.

- **Roof Structure (Priority 1):** An historic restoration structural engineer should analyze the roof structure of both the Parish House and the Rectory and make recommendations. The necessity to redesign the parapet supports provides an opportunity to upgrade the roof anchoring and support system as well.

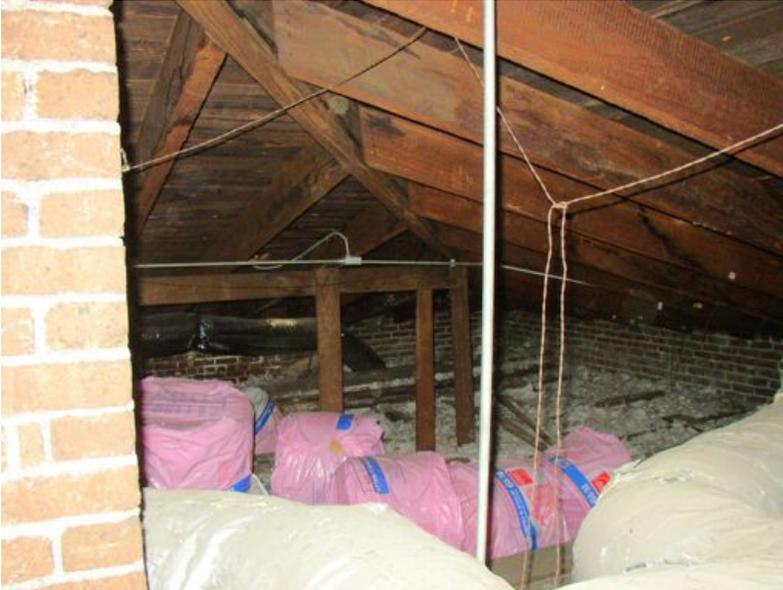
Figure 15: Parish House south east hip rafter

- **Decking (Priority 1):** Remove the six inch nails from the roof decking and repair same. This can be done when the parapet tie-backs are removed and a new copper roof installed.

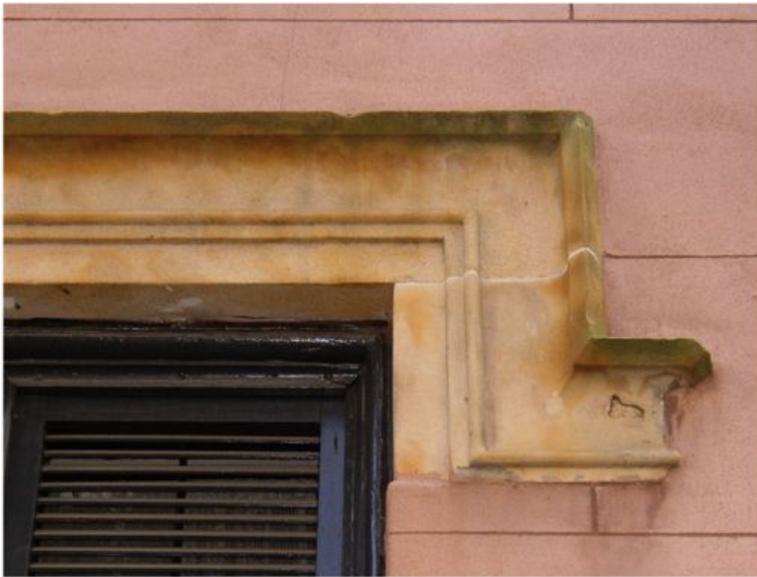
Figure 16: Stone drip mold showing erosion and stucco problems

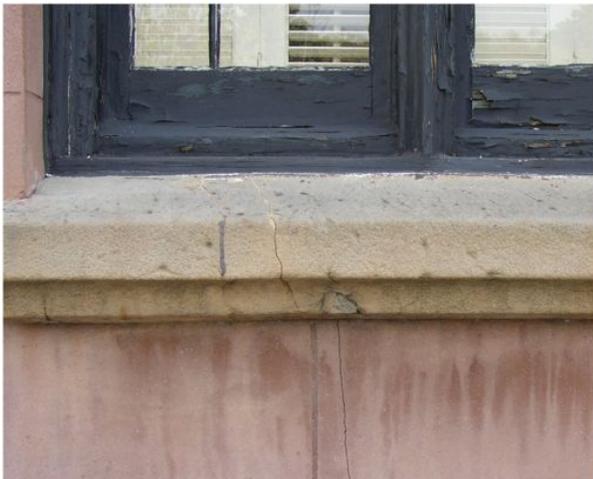
- There is a hairline crack passing up through the northernmost wall and stone window heads and sills of the west (Whitaker Street) elevation, starting at sidewalk level. This is most likely a result of the vibrations from the large amount of traffic on Whitaker Street. It does not appear to be active. However, there is a damp area on the inside of the wall. As this is the back wall of the original stable, there may be an old drain under the wall that is the source of the crack.

Figure 17: Crack in Whitaker Street Rectory wall

- **Crack repair (Priority 2):** The Whitaker Street crack which extends through two sills, a header, and the stucco should be monitored to determine if there is still movement. Use crack monitoring test strips. If the crack is stable, then an injection of the Jahn M30 or M40 or equivalent would be a suitable repair.
- **Biological growth (Priority 2):** Remediate on plinth facing stones with the use of

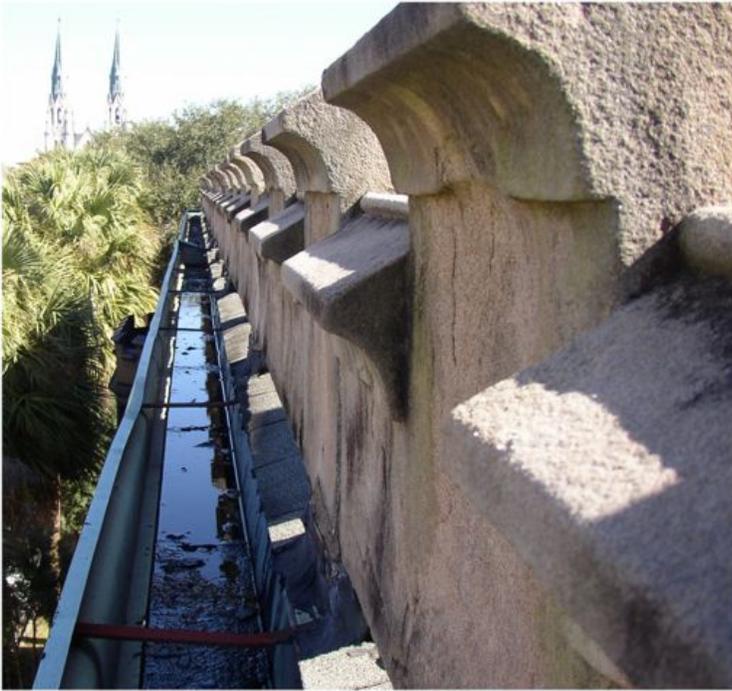
Figure 18: "Flying" parapet to north wall of Parish House

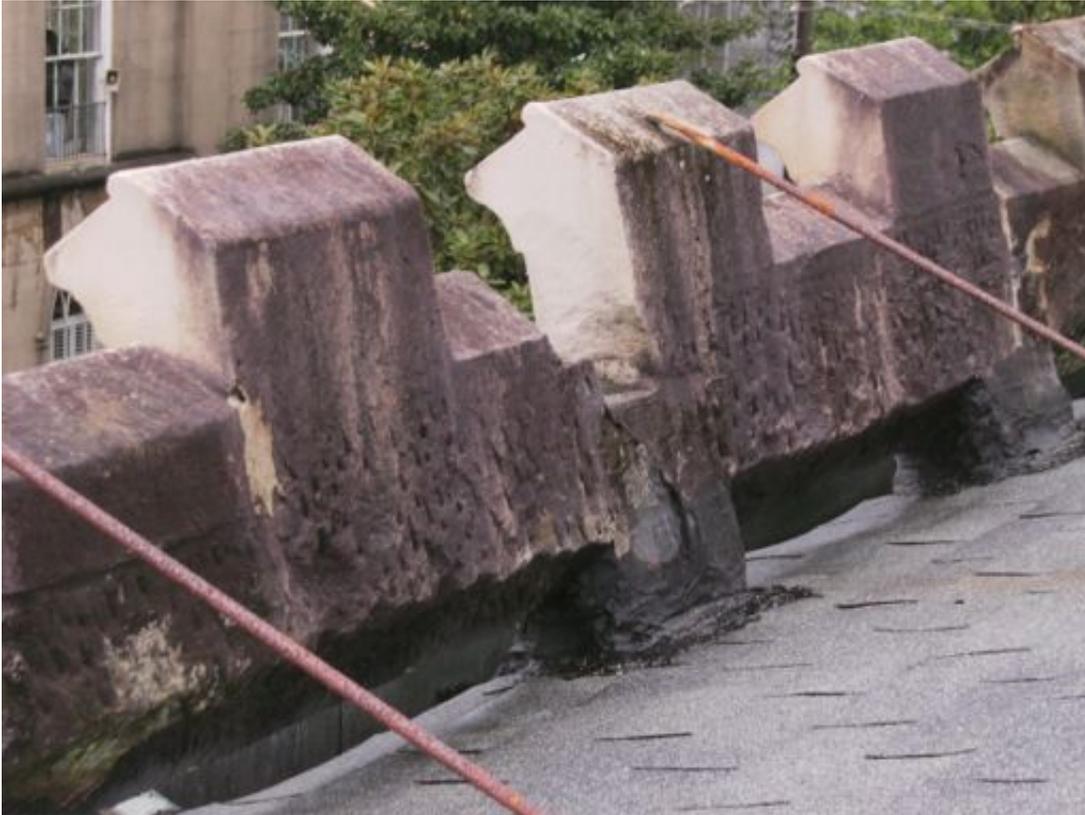
- The brick parapet supports are failing in places, particularly on the south wall, causing the stones to shift outwards. Workmen in 1968 tied the stones back into the roof structure with iron rods and removed the original copper roof system inside the parapets, replacing it with tar and shingles (see Figure 2). They also put six inch nails through the roof decking, and removed some of the intermediate supports to the larger stones.

- Stones have continued to shift and tar flashings have failed causing continued erosion of the supports. A few stones have cracked at clamp location breaking the continuity of the structural ring. A substantial section of the south main parapet is leaning outwards. There is also one place on the main east parapet next to the northernmost of the small middle chimneys where the stones have shifted.

Figure 19: Leaning south parapet

- **(Priority 1):** An historic restoration structural engineer should do an analysis of the parapet support system of both the Parish House and the Rectory and make design recommendations. It is the intension to preserve the original stones in their original locations, ideally without tie-backs, and without cutting through the original clamps. However, this may not be feasible.

- **(Priority 1):** Structurally stabilize the parapets on newly engineered support system. Stainless steel angles could be added at existing or intermediate locations, determined in coordination with the design of the new copper roof. Stitching or partial replacement may be necessary in places. As the exterior brick wall is thinner in the Rectory than the Parish House, the support solutions may have to be different.

- **(Priority 1)** Parapet stones need to be patched, cleaned and reset.
- **(Priority 2)** Reattach the broken pieces that can be located.

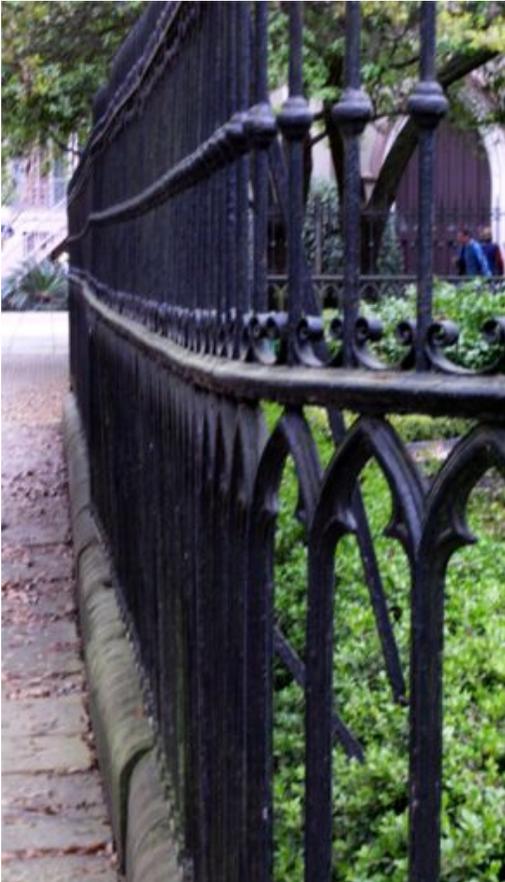
- Ironwork support points have rusted and expanded, eroding the stone base, and leaving the fence unsupported in places.
- Fence is undulating due to support problems.
- Base stones themselves are misaligned, spalling, missing pieces, and covered with biological growth in places.
- Hollow cast iron base rail of the 1890 fence extension is in poor shape and some sections have fallen off. These have been salvaged and stored.
- Practically no parts are missing to the original fence, but some corroded support points must be replaced.
- There is an excess of paint on the ironwork which is now peeling and flaking.

Figure 20: Front formal garden fence support failing

- **(Priority 1)** Identify points where the ironwork is no longer supported and reconstruct the support using Jahn or equivalent mortar.
- **(Priority 1)** Prior to repair, prep the fence supports to remove all rust and recoat to prevent future oxidation.
- **(Priority 1)** Clean, repair, patch, and reset base stones as necessary.
- **(Priority 1)** Inspect, replace as necessary bolted ironwork connections.
- **(Priority 1)** Realign and stabilize the fence to the extent that it can be done without dismantling it, if possible. Note: if the ironwork is removed for repair, great care must be taken to make sure it fits back together again correctly. The base stones and ironwork support points are irregular.
- **(Priority 2)** Replace missing or damaged decorative parts.
- **(Priority 2)** Clean, repaint ironwork as necessary.

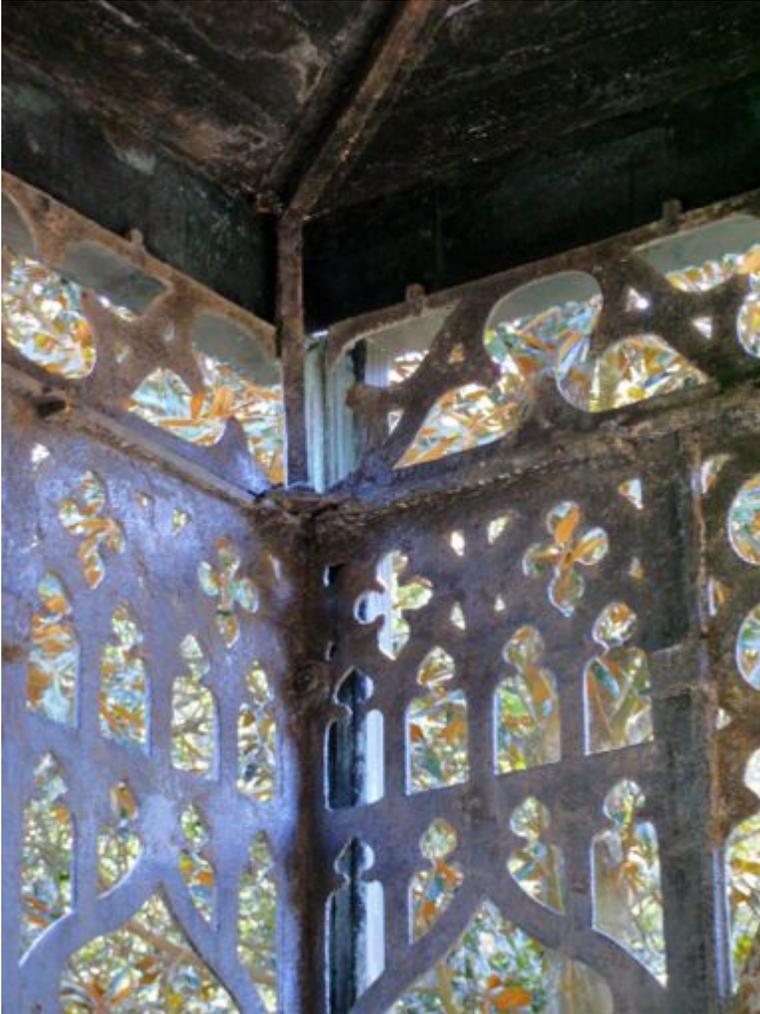
Figure 22: South east veranda corner

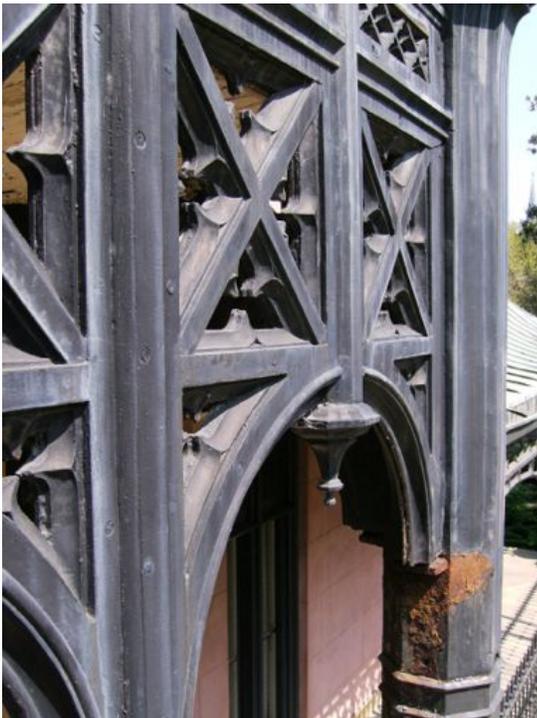
- The spectacular and unique ironwork suffers from rusting and excess paint. Parts have fallen from the entrance portico due to water getting inside the cast iron structure.
- For some reason, the copper flashing was not taken completely over the top of the portico upstand, leaving a gap between the inside and outside face which was later filled with caulk which then failed. No maintenance manual came with this house, and a lot of damage has occurred through not knowing what to do with the water getting through the top of the upstand, i.e. keep it out, let it flow through and the air circulate, or worst case (which was done) leave it open at the top and seal it at the underside.

Figure 24: Portico losing parts due to rust

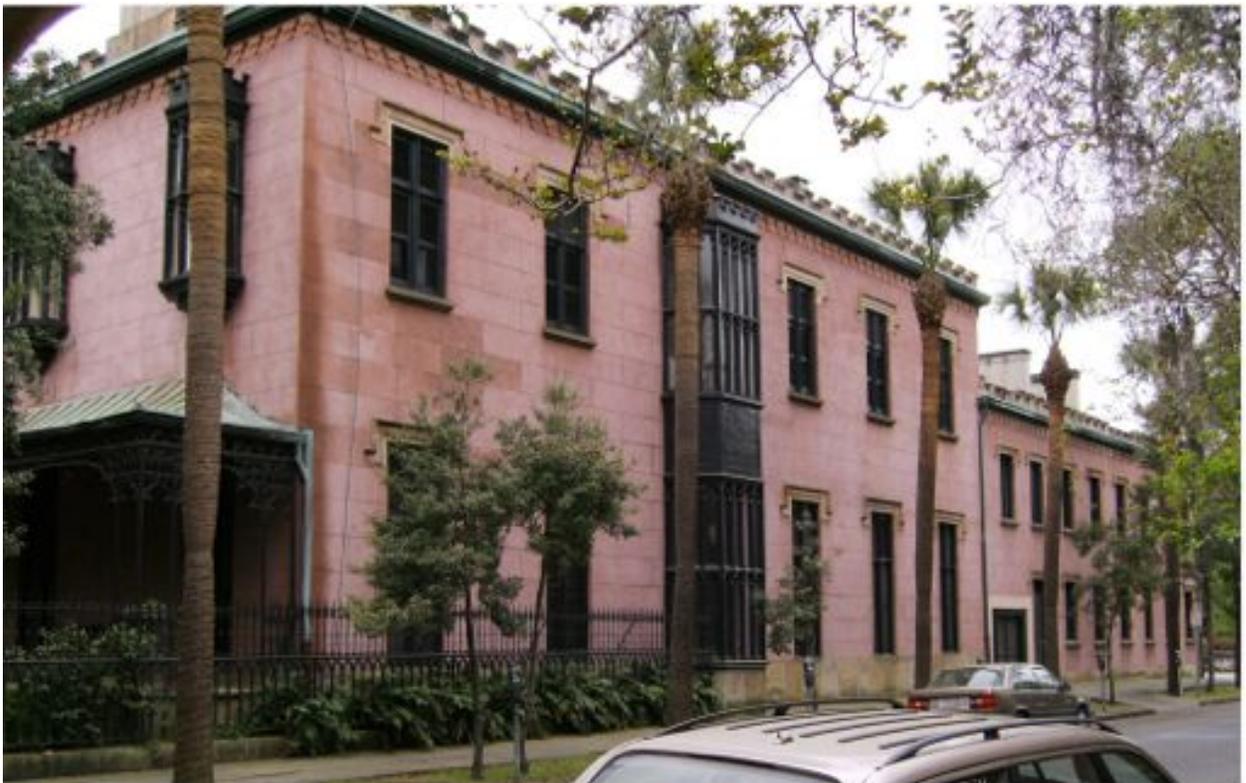
Figure 25: Harris Street (North) elevation

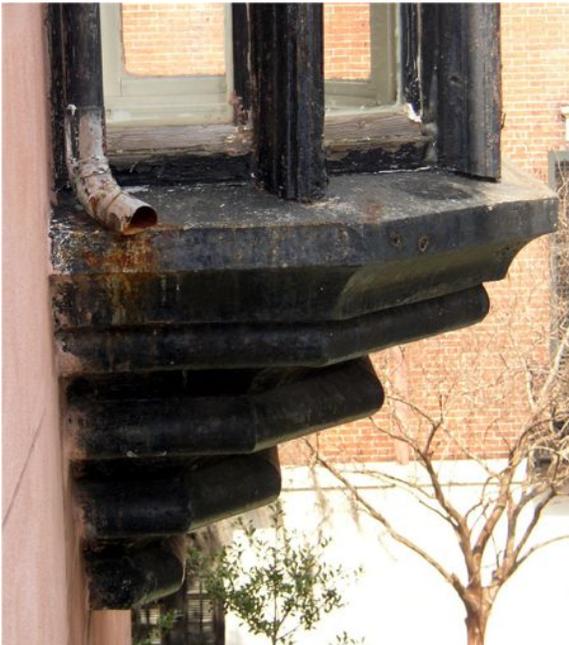
Figure 26: Oriel window downspout

- **(Priority 2)** Replace the missing downspout. It may be in the attic.
- **(Priority 3)** Dismantle the iron tracery parts, clean and refinish. Check face plates.
- **(Priority 3)** Research historic photographs and other sources to determine exactly how the original opening casements were constructed. Include their reconstruction in the long range plan.

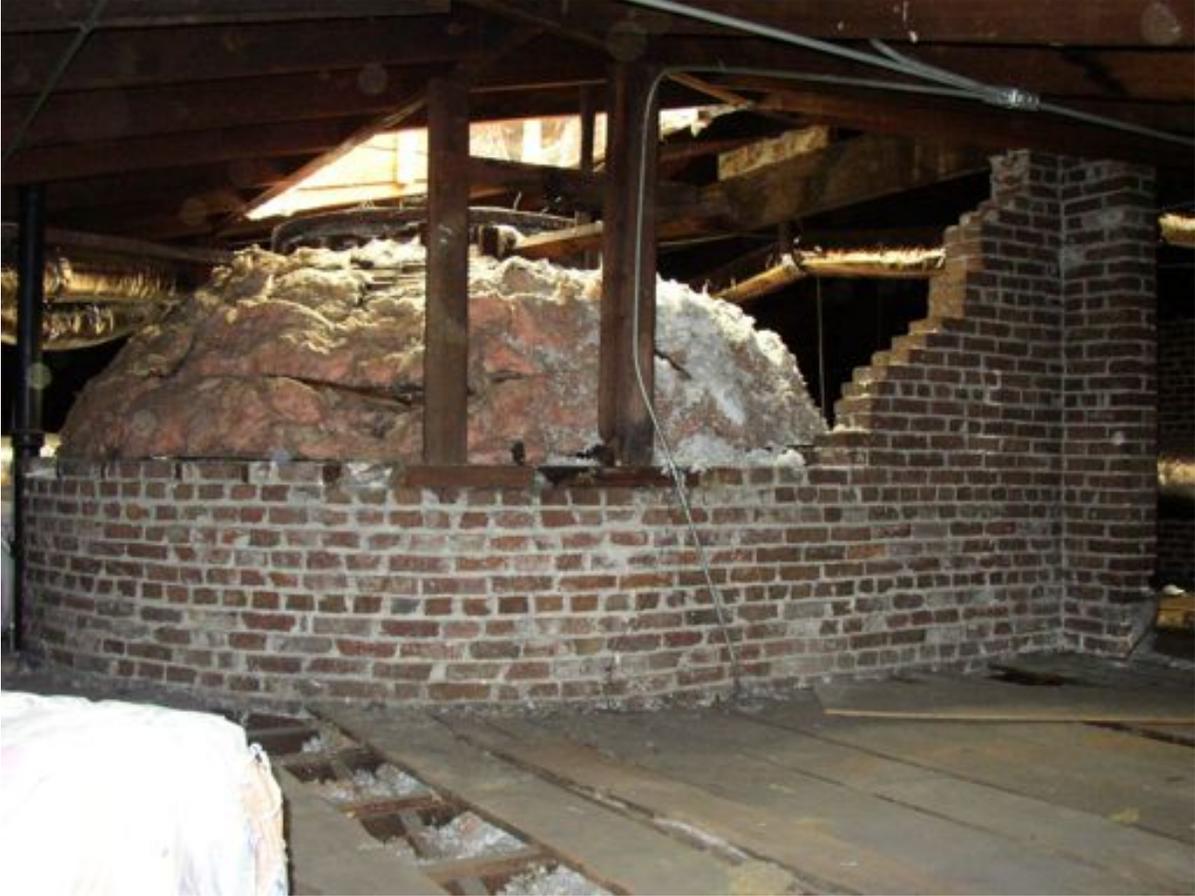
Figure 29: Attic view of dome, oculus and skylight

- Restore the original skylight if possible.

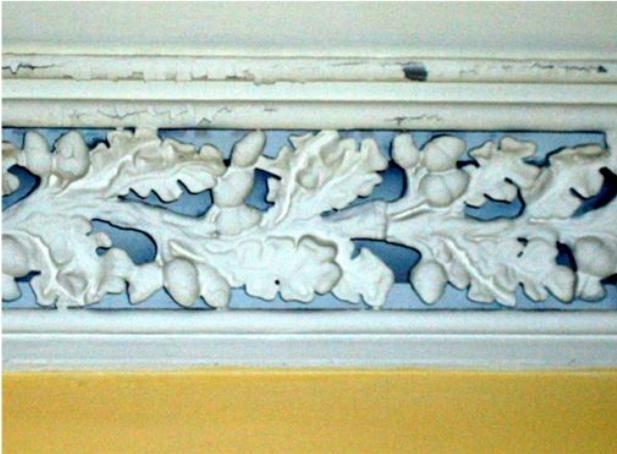
Figure 30: Excess and flaking paint to moldings

- **(Priority 3)** Clean and repair interior plaster ornament throughout the Parish House.

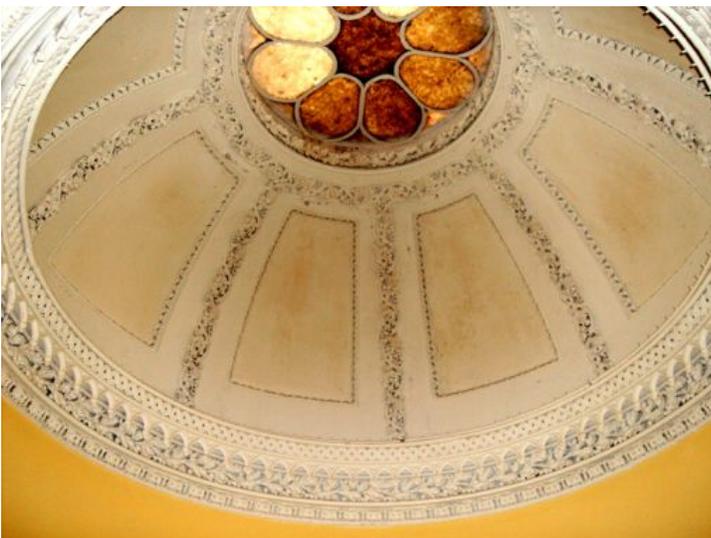
Figure 31: Interior of dome over stairs. Note ring of gas jets at base for lighting.

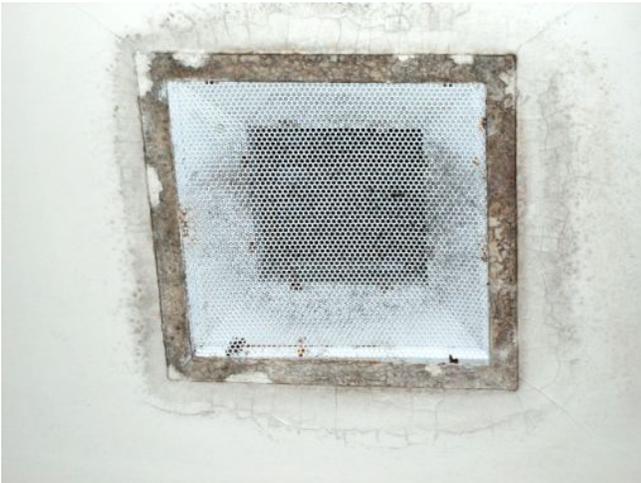
Figure 32: Second floor ceiling HVAC duct

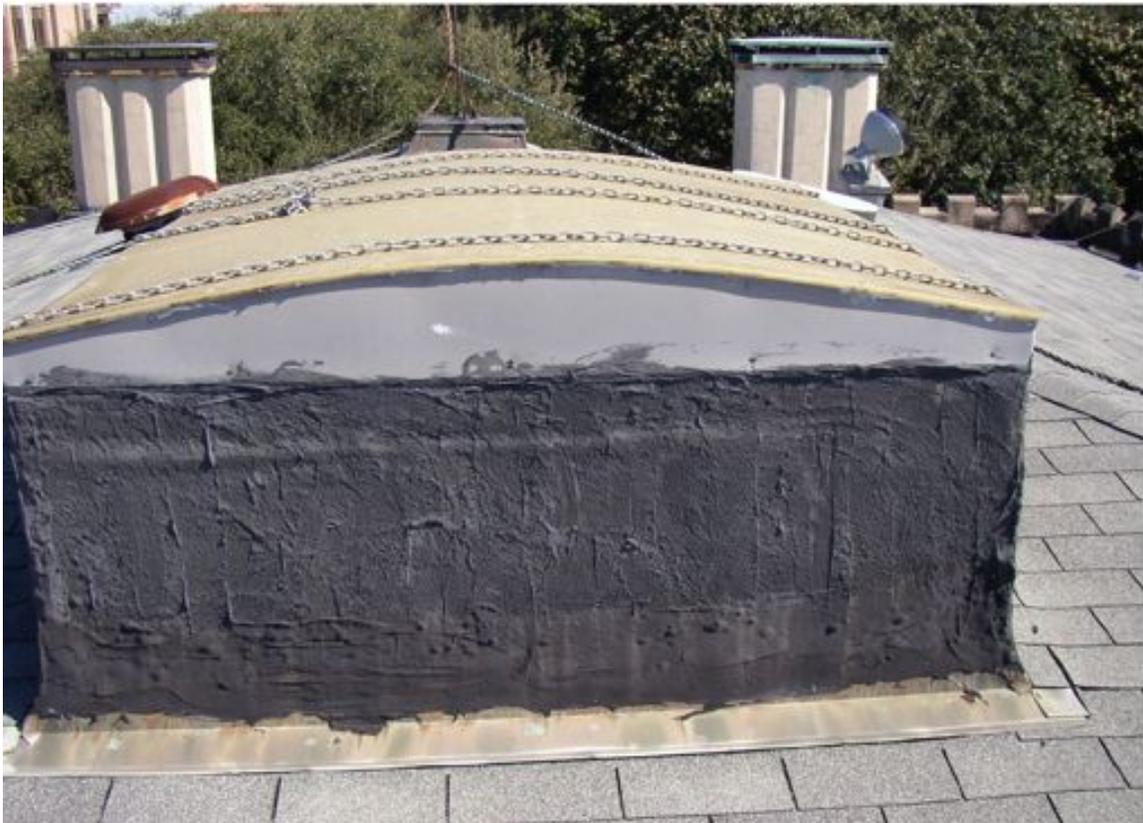
Figure 33: Skylight box with lightning rod behind at apex of roof and cables extending in three directions to ground.
