HISTORIC STRUCTURES REPORT AND CONDITION ASSESSMENT

GREEN-MELDRIM HOUSE

1 West Macon Street
Savannah, GA, 31401

20 April 2007

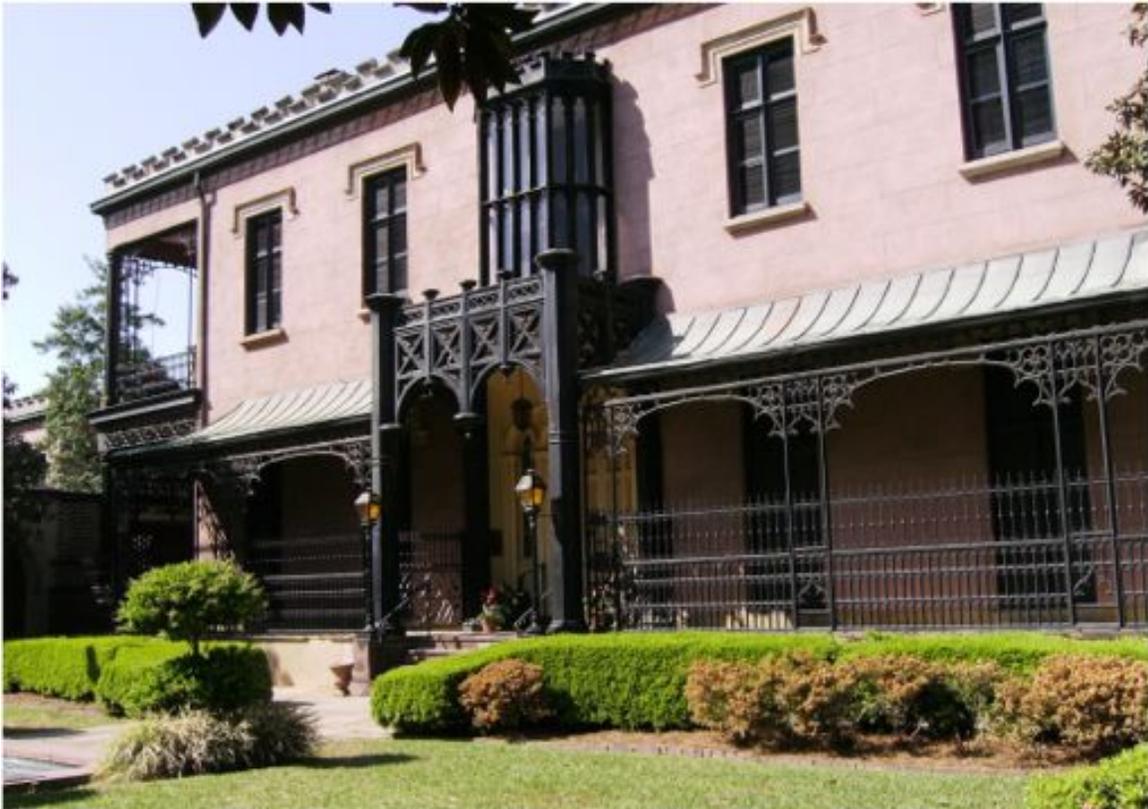
Figure 1: View from Macon Street (closed in 1960)

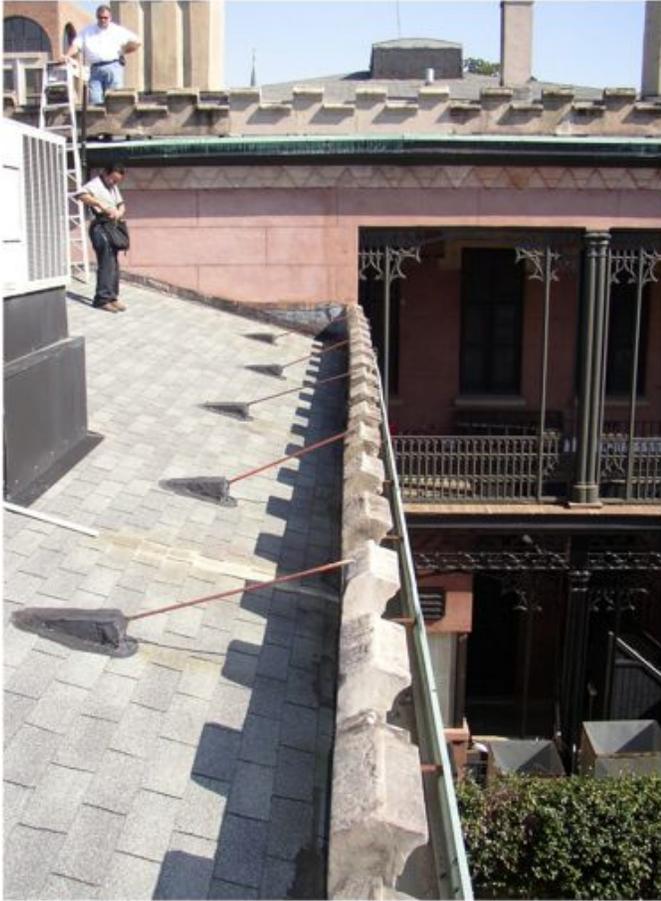
Figure 2: Back Plaza from Rectory Roof

- The brick parapet supports are failing in places, particularly on the south wall, causing the stones to shift outwards. Workmen in 1968 tied the stones back into the roof structure with iron rods and removed the original copper roof system inside the parapets, replacing it with tar and shingles (see Figure 2). They also put six inch nails through the roof decking, and removed some of the intermediate supports to the larger stones.

The present main roof to the Parish House and Rectory is shingles on tar, with tar flashings. The original copper was removed to install tie-backs to the stone parapets (See Figures 2, 18, 19).

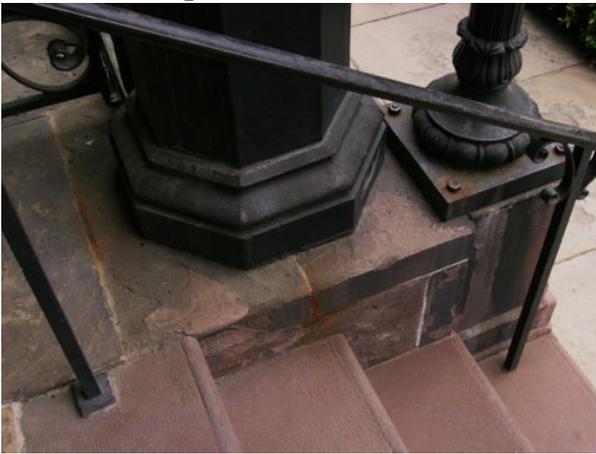
Red sandstone steps rise 2'6" beneath the front portico to the south veranda. On either side are composite red sandstone bases for cast iron light standards and for the monumental portico cast iron columns. There are iron handrails either side (See figure 27).

- The red sandstone front steps have multiple earlier patches, some of which have discolored and are starting to fail. The exterior surface is delaminating in places. The full weight of the iron portico is resting on the composite red sandstone blocks either side of the steps, and the bolts holding them in place are starting to rust, as are the bolts holding the iron lampposts.
- The back piazza steps are now separated from the Rectory garden by a high modern wall. A modern kitchen now extends into the back porch and across part of the top of these stairs which are overrun by the air conditioning unit piping (See Figures 2 and 6).

- **(Priority 2):** Use properly tinted Jahn M70 mortar or equivalent to repair the damaged red sandstone entrance steps. Prior to repair, prep the iron portico columns, lampposts, and handrail bases to remove all rust and recoat to prevent future oxidation.
- **(Priority 2):** Repoint the Whitaker Street Rectory steps and patch with tinted Jahn M70 mortar or equivalent.

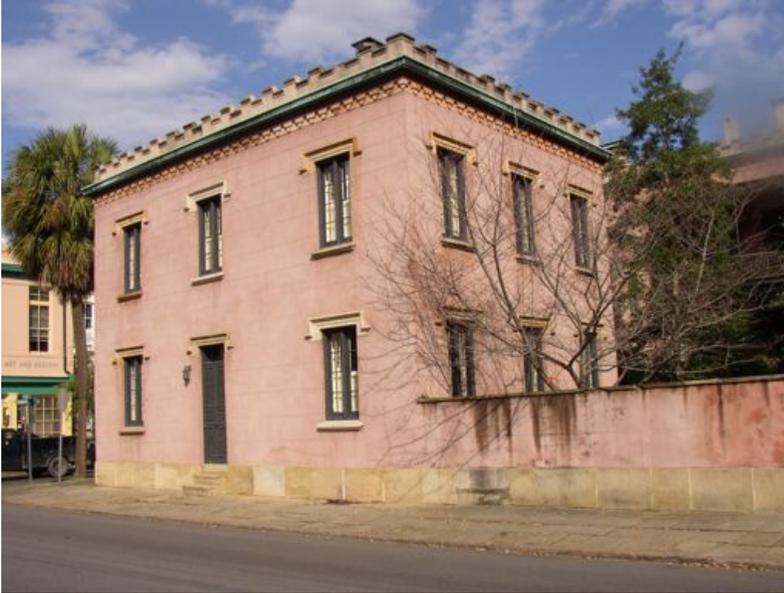
- The Whitaker Street steps encroach awkwardly onto the sidewalk. This was a ground level stable access door originally. The flagstones are broken and loose in places.

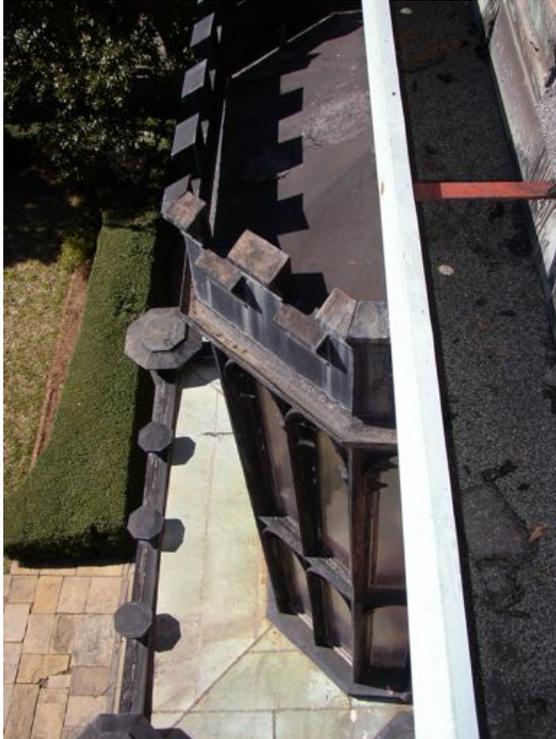
- The spectacular and unique ironwork suffers from rusting and excess paint. Parts have fallen from the entrance portico due to water getting inside the cast iron structure.
- For some reason, the copper flashing was not taken completely over the top of the portico upstand, leaving a gap between the inside and outside face which was later filled with caulk which then failed. No maintenance manual came with this house, and a lot of damage has occurred through not knowing what to do with the water getting through the top of the upstand, i.e. keep it out, let it flow through and the air circulate, or worst case (which was done) leave it open at the top and seal it at the underside.

- **(Priority 1)** Insert new supports as necessary (may necessitate shoring of the veranda roof structures to ensure no stress is put on the connection system). Check alignment.
- **(Priority 1)** Inspect, replace as necessary any structural iron parts of the pagoda roof and supports.
- **(Priority 1)** Inspect, replace as necessary bolted ironwork connections.
- **(Priority 1)** Treat trellis supports to prevent further corrosion of stone floor slabs.
- **(Priority 2)** Replace or repair as necessary decorative ironwork parts.
- **(Priority 2)** Clean, repaint ironwork as necessary.
- **(Priority 2)** Check pagoda copper roof flashings, gutters, and downspouts and repair or replace as necessary.
